CONTAINER LOADING INSPECTION REPORT

Conducted by Jacky

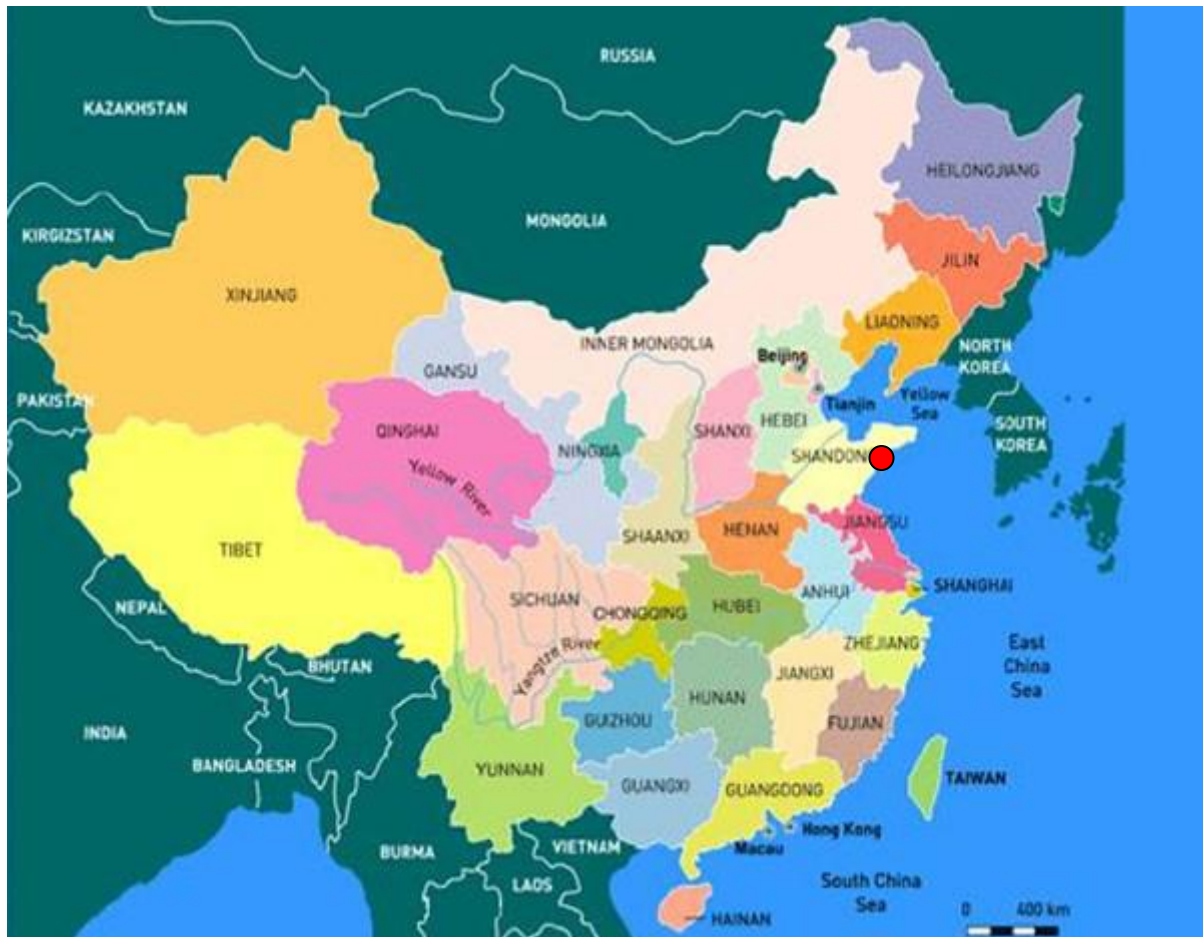
Important Remarks / General Defects

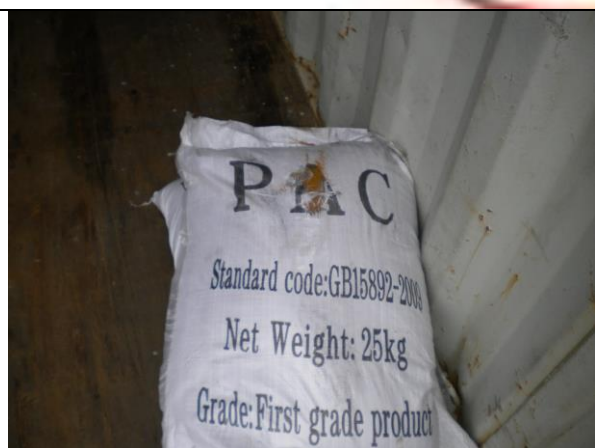
Photos of Products remarks and defects
