# Pre-Shipment Inspection

<b>Product:</b>	Plywood Sheeting
<b>Goodada ID#:</b>	284
<b>P/O Number:</b>	XXX
<b>Client Name:</b>	XXX
<b>Seller Name:</b>	XXX
<b>Inspector Name:</b>	Frank Ge
<b>Location:</b>	Linyi City, China
<b>Inspection Date:</b>	XXX

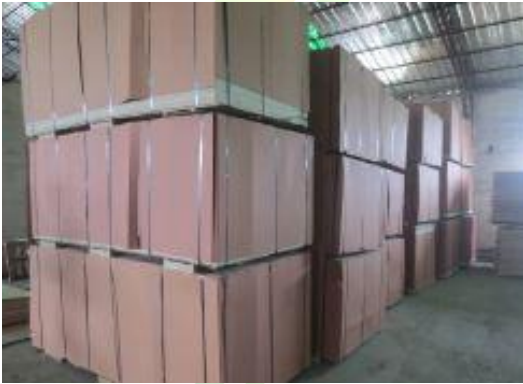
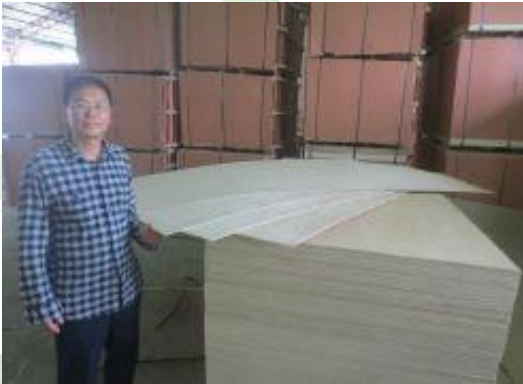
**COMMENT:** Images above show inspector locating the products and counting the amount which conform to clients requirements.

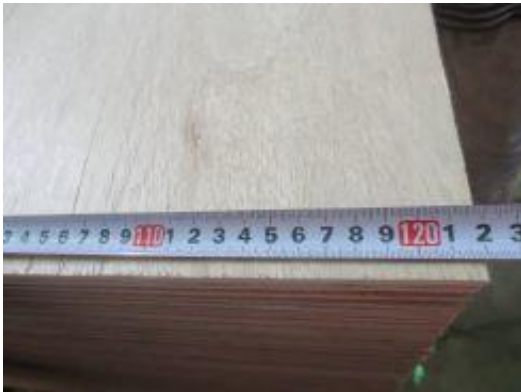
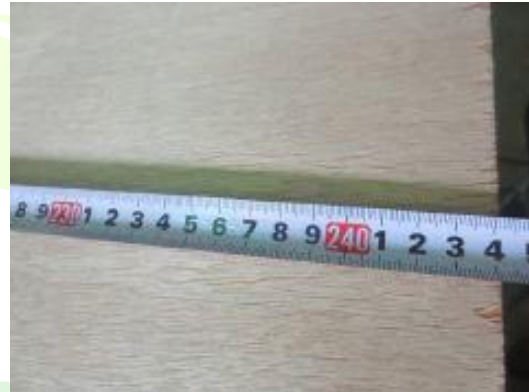
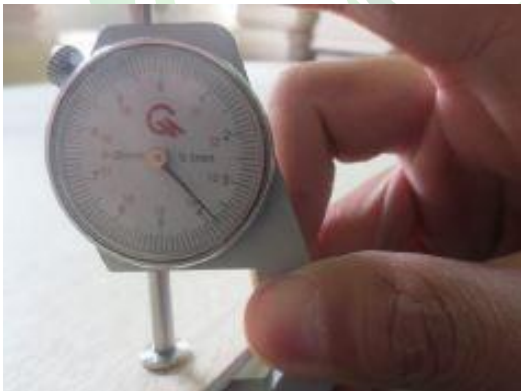
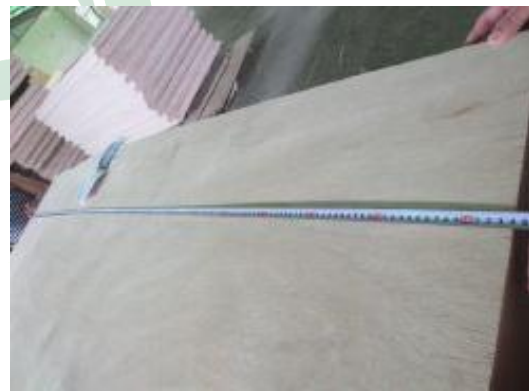
Expected Result	Result	Actual Finding / Comments
2440 x 1220 x 4mm	Client Verification needed	Length and width pass but thickness is smaller than clients requirements.

**COMMENT:** Thickness of material will need to be verified by customer.

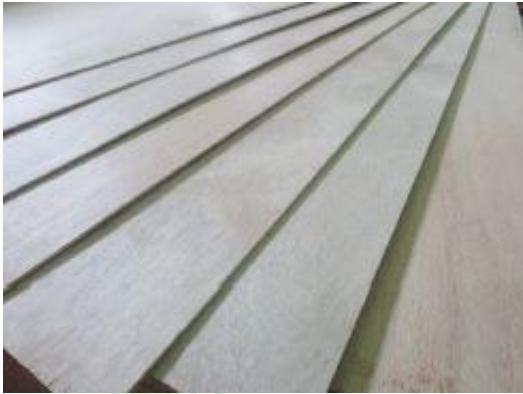
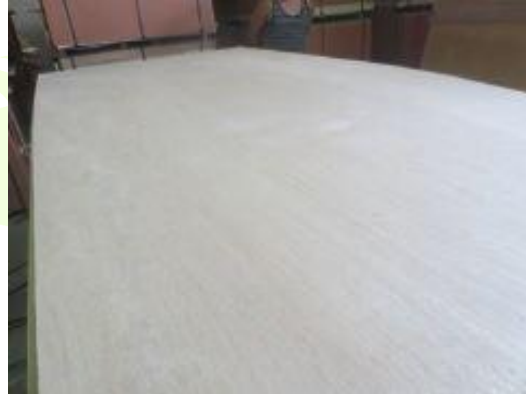
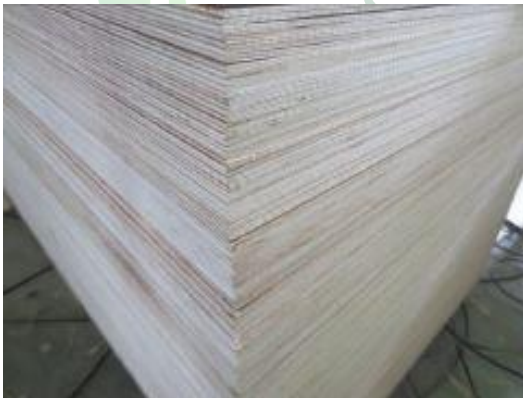
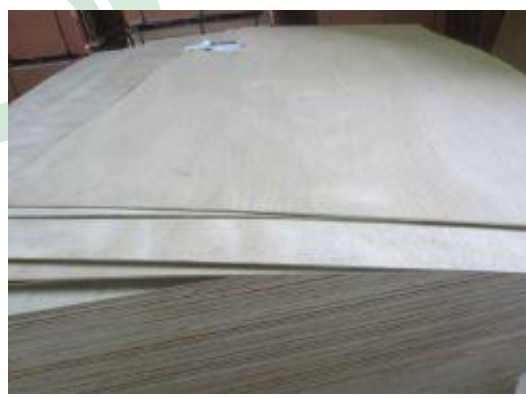
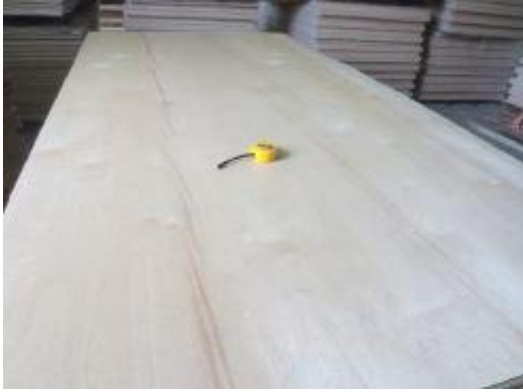
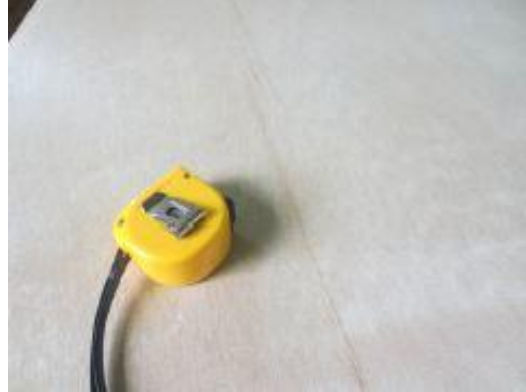
**COMMENT:** All products checked conform to clients colour requirements on front and back side.

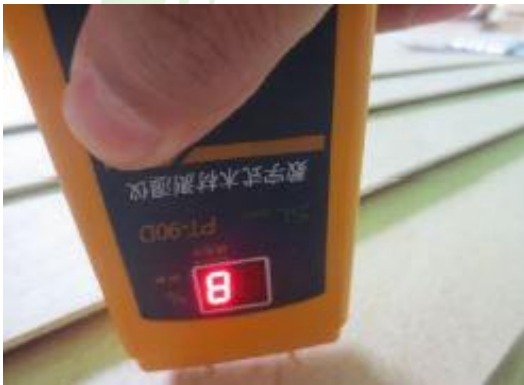
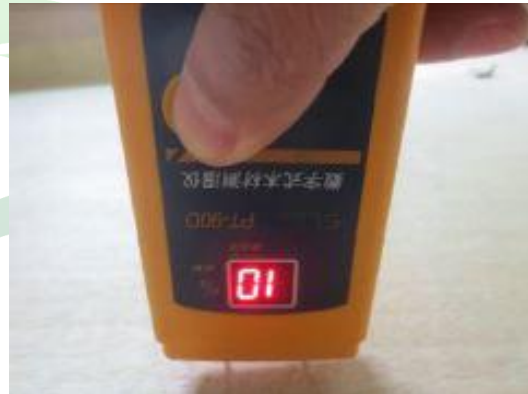
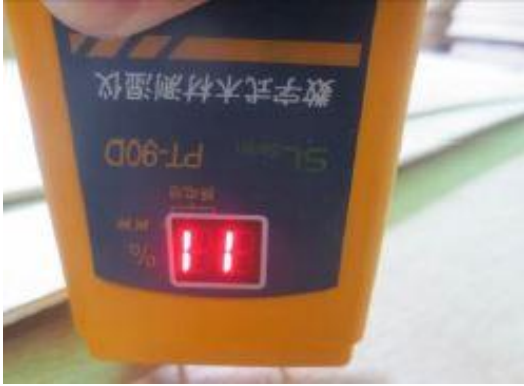
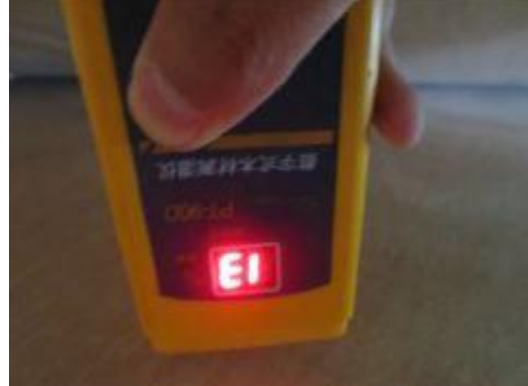
**COMMENT:** Moisture test was carried out with a pass results on all tests.

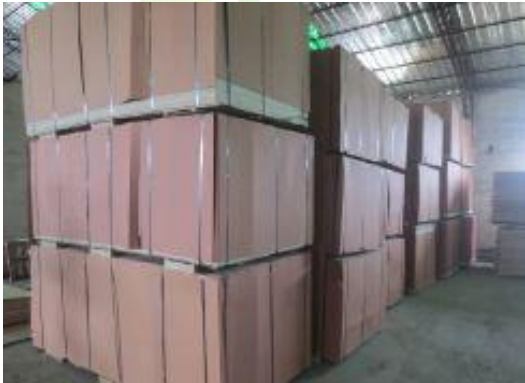
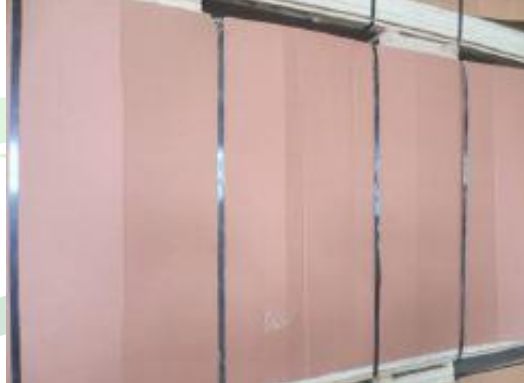
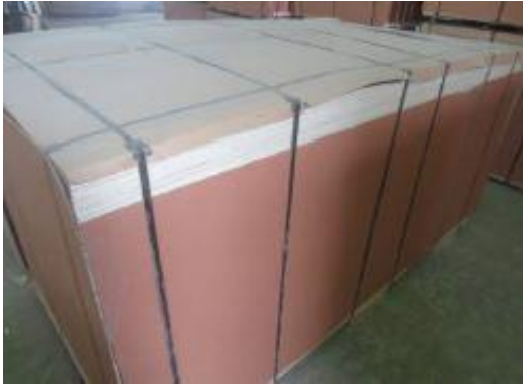
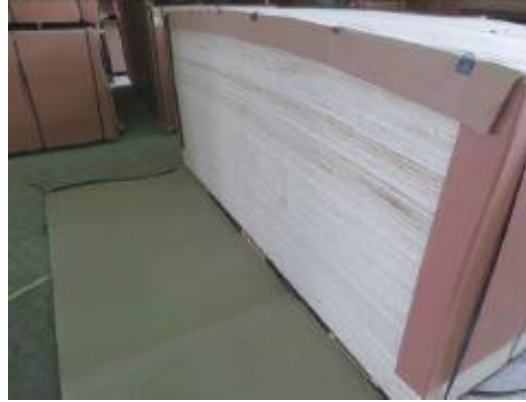
Expected Result	Result	Actual Finding / Comments
All products should be wrapped in polymer bag, then wrapped on cardboard and tied together with steel straps.	Fail	There was no polymer bag used during the wrapping of the product. Client needs to verify this.

**COMMENT:** No polymer wrapping found in tested products.

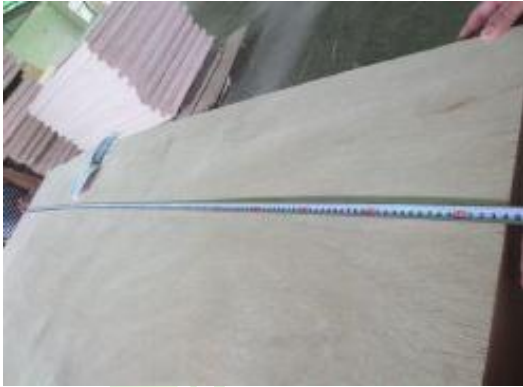
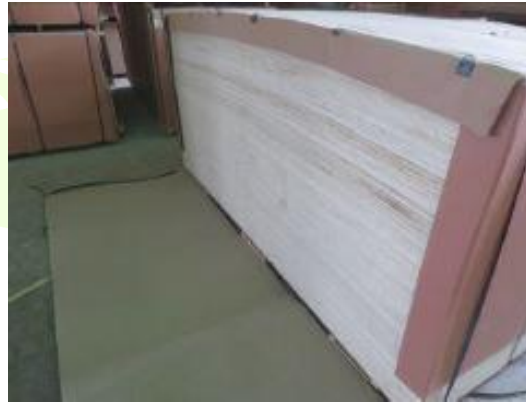
**COMMENT:** Pallets consisted of 250 sheets stacked onto top of one another and wrapped securely.

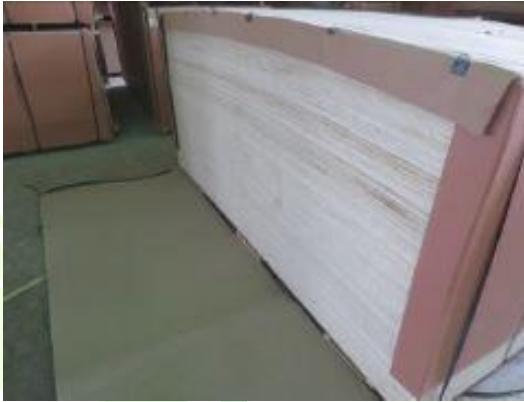
<p>Figure 33</p>
The back side of sheets were found to have colour variation			5

Defects Summary Photos				
Product Defect	Critical	Major	Minor	Image
No Polymer bag used in packing		1

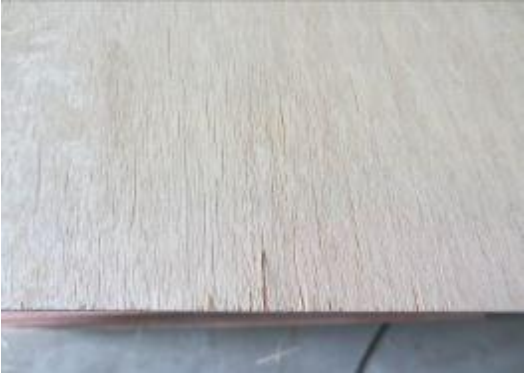
<p data-bbox="1040 611 1143 638">Figure 35</p>
----------------------------	--	--	---	---

Edge damage on two samples			2

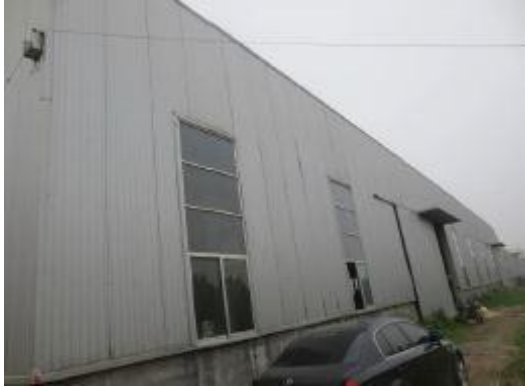
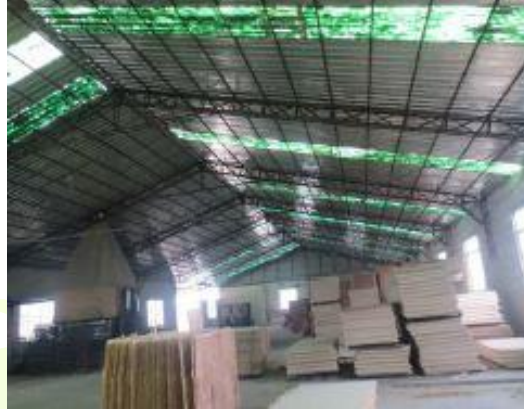
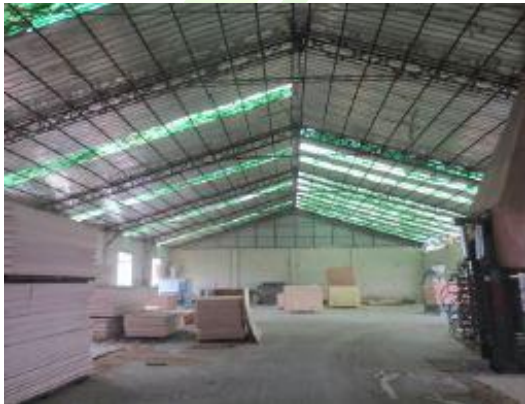
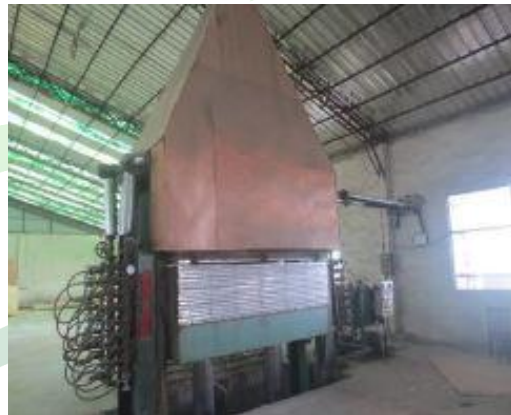
Comments: Images above show the factory facilities.
