Container Loading Inspection

Product:	Salt Tablets
Goodada ID#:	XXX
P/O Number:	XXX
Client Name:	XXX
Seller Name:	XXXX
Inspector Name:	Mohamed Karem
Location:	Damietta, Egypt
Inspection Date:	XXXX

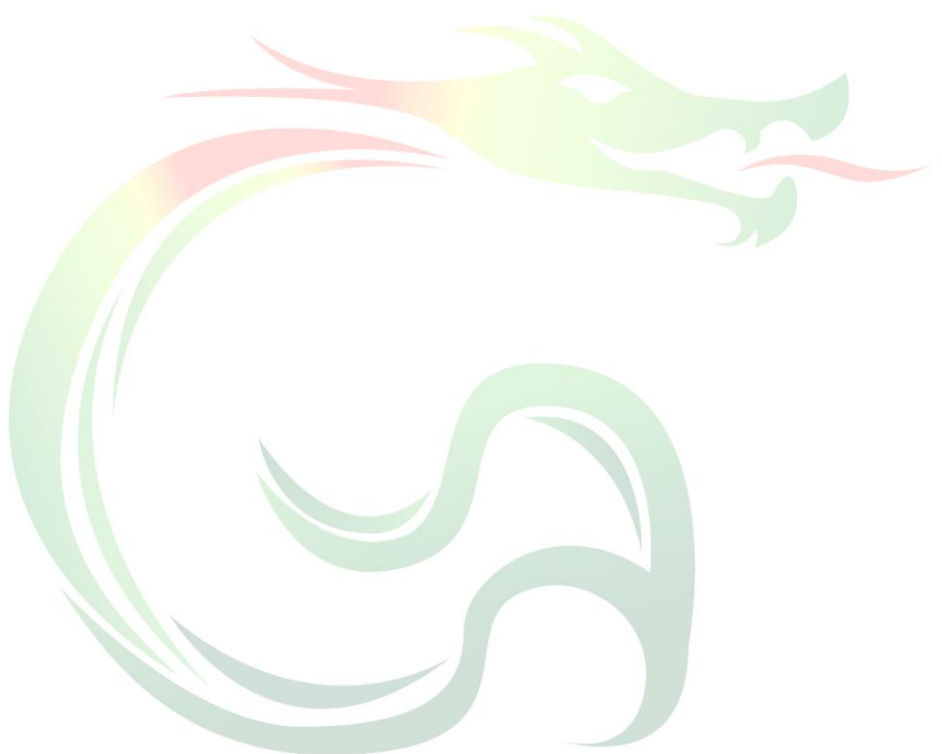
Inspection Details	
Supervisor

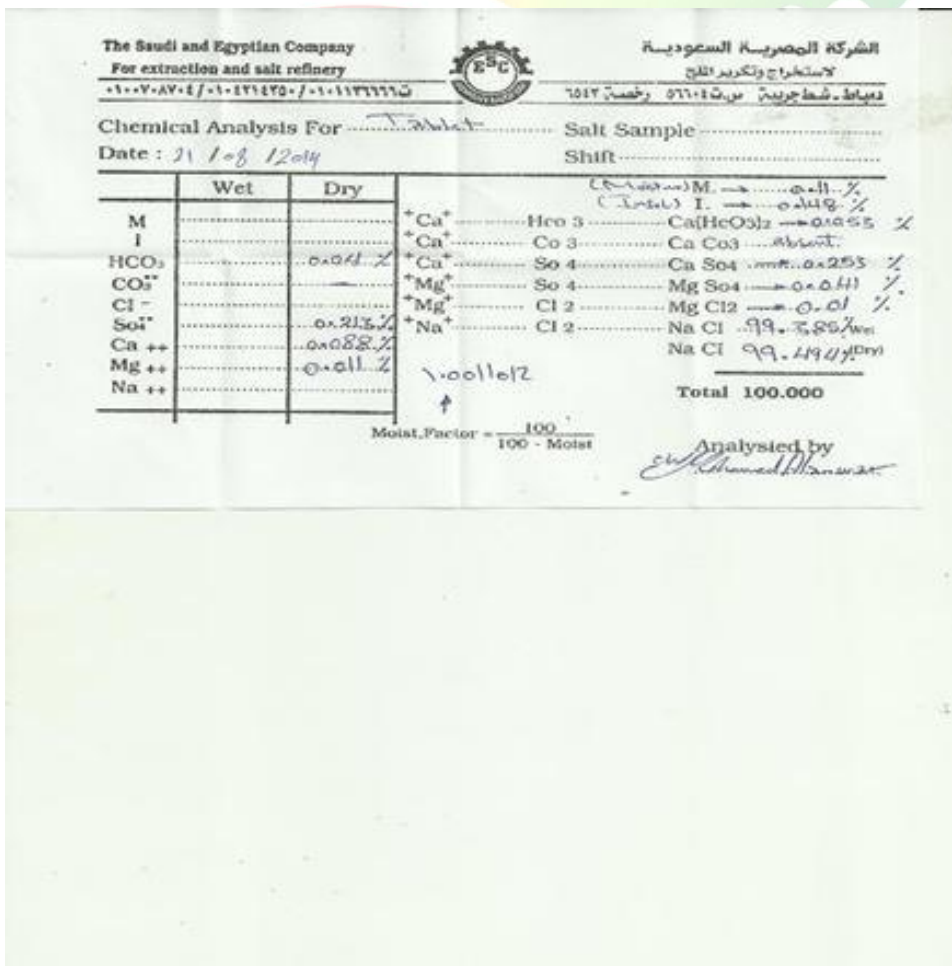
<p>The Saudi and Egyptian Company For extraction and salt refinery ٠١٠٧٠٨٧٠٤ / ٠١٠٤٣١٤٢٥ / ٠١٠١٣٣١١٦٦٥</p> <p>الشركة المصرية السعودية للاستخراج والتكرير والملح لمياه شط جريدية ص ٥٦١٠٤٢٥ وخصر ٦٥١٢</p> <p>Chemical Analysis For <u>Salt Sample</u> Date : <u>21 / 08 / 2014</u> Shift <u>.....</u></p>

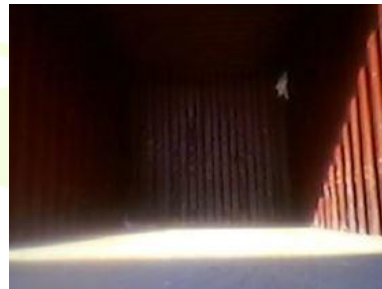
Figure 17-Empty MSCU 215046/0

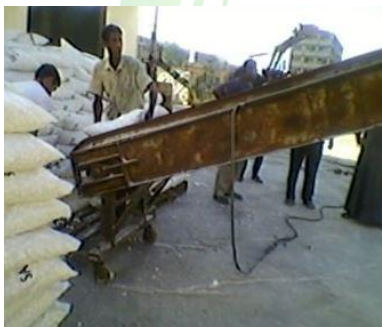
<p>Figure 18-Loading of salt onto conveyor</p>

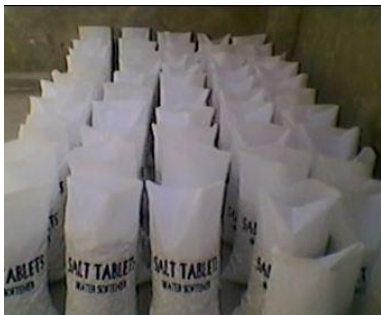
Figure 26-Tablet protection bags

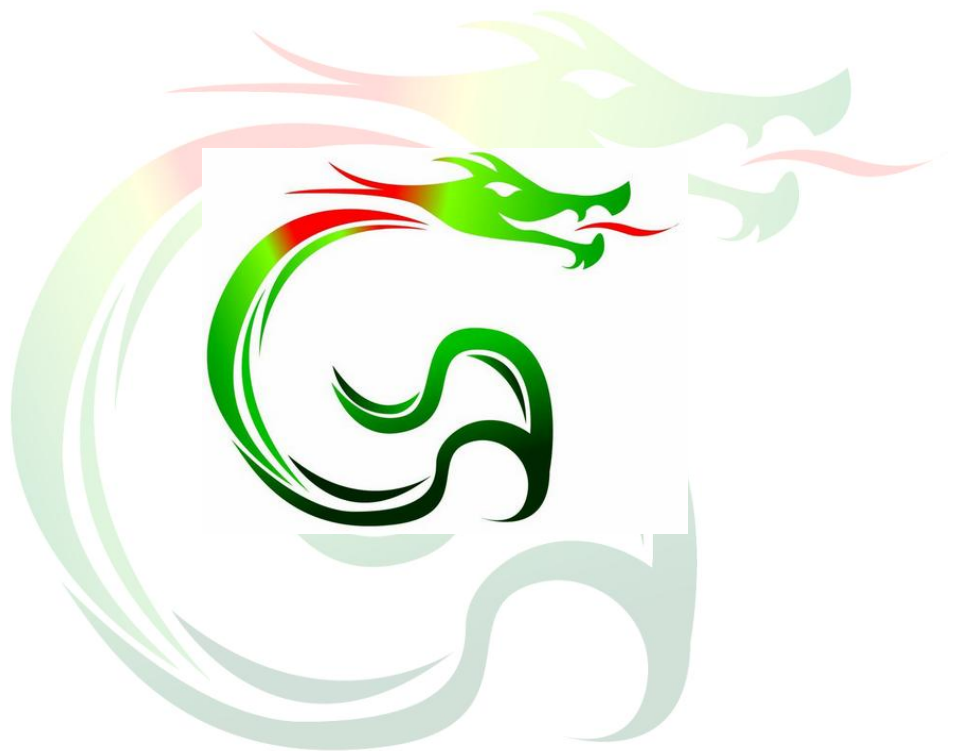
*“It’s always better to find a fault at the factory floor and not
at your door”*
